# Application News

## No. A499

Spectrophotometric Analysis

### Confirmation of Raw Material Quality -Dealing with "Silent Change" Counterfeiting-

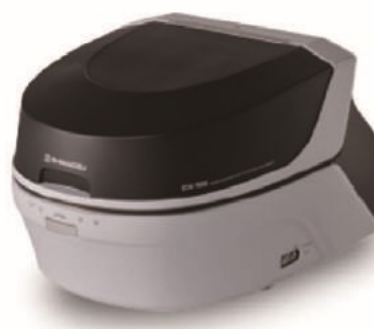
Fig. 1 EDX-7000 Energy Dispersive X-Ray Fluorescence Spectrometer

In this article, we use samples that may have been subject to a "silent change" (hereafter called "silent change" product) and introduce case analyses that confirm such changes using energy dispersive X-ray fluorescence spectrometry (EDX) (Fig. 1) and FTIR infrared spectrophotometry (Fig. 2).

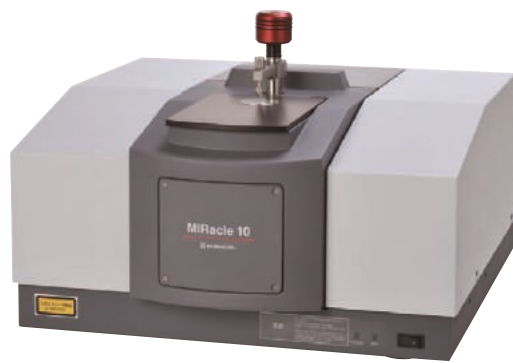
Fig. 2 IRAffinity-1S with MIRacle 10 Single-Reflection ATR Accessory

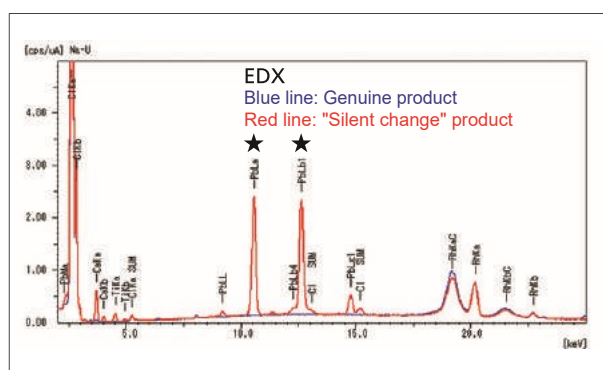
Fig. 5 shows that lead (marked with a star) was detected in the "silent change" product that was not detected in the genuine product. The plastic material analyzed in this experiment is subject to regulation under the Restriction on Hazardous Substances Directive (RoHS) and must not contain any lead. The results show that the "silent change" product does not meet the RoHS regulations.

Fig. 5 Results of EDX Analysis of Genuine Plastic Product and "Silent Change" Plastic Product

We used EDX and FTIR to analyze a genuine polyvinyl chloride (PVC) product, and a "silent change" plastic product. The EDX analytical conditions are shown in Table 1 with corresponding profiles shown in Fig. 5, while FTIR analytical conditions are shown in Table 2 with corresponding spectra shown in Fig. 6.
